# **Closure Report Greyhound Lines, Inc. Maintenance Center**

San Diego, California

Volume I - Technical Report

**February 1990**

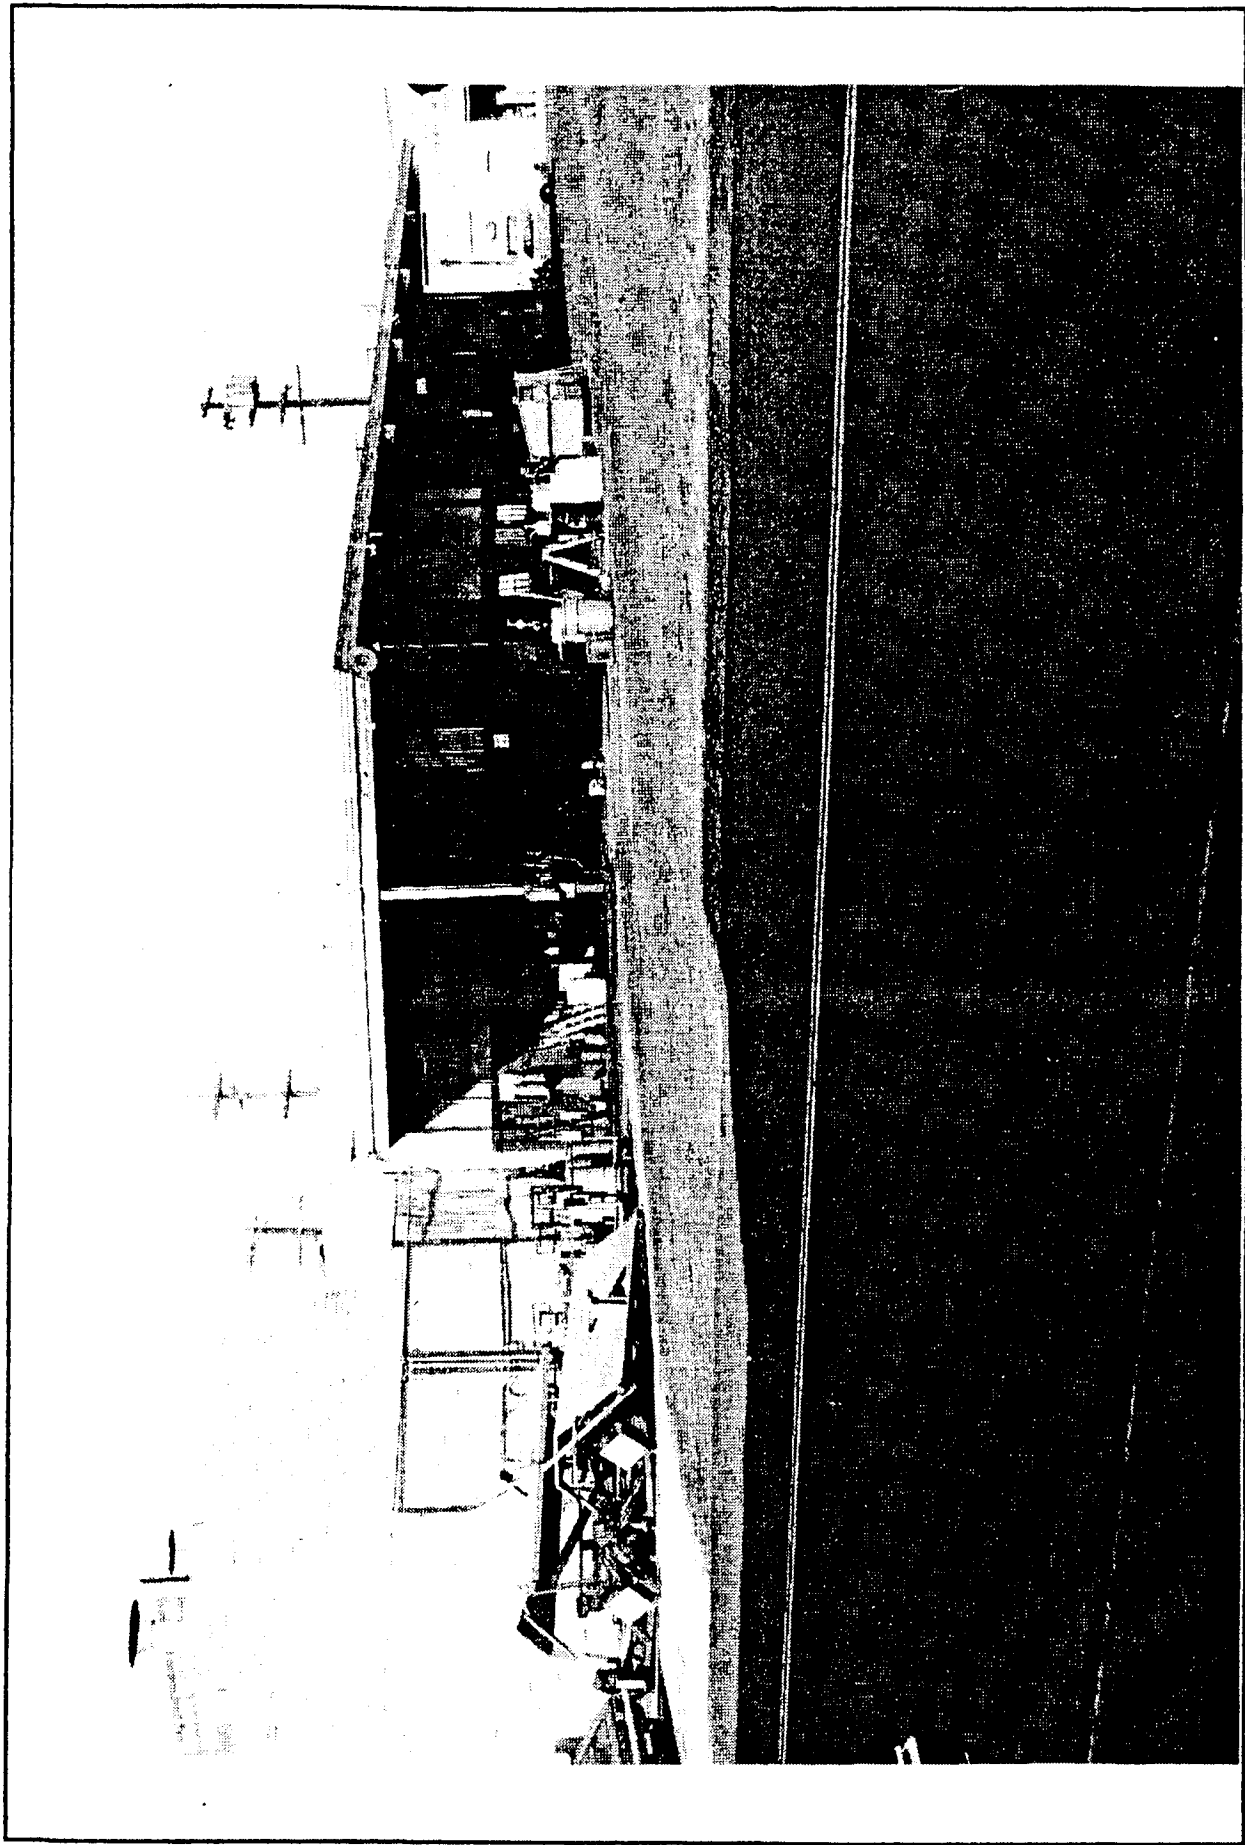
2-2

Former GLI Service Building Until 1973

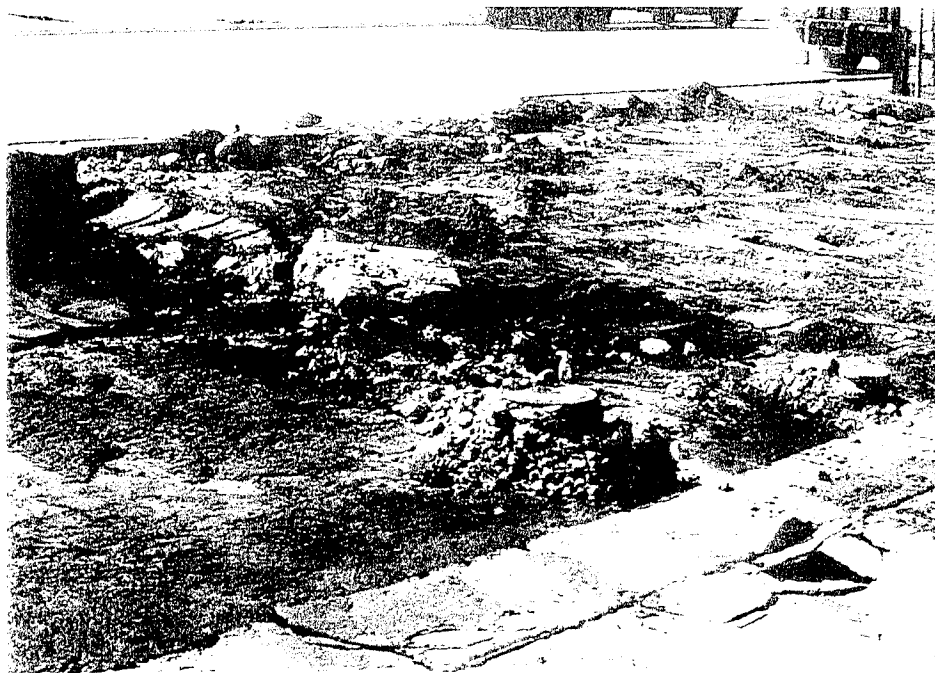
Removal of the concrete overlying the diesel tanks began on September 7, 1989 by Angus Asphalt. The soils immediately underlying the concrete were inspected to determine if contamination from above had occurred. It was noted during this inspection that surface contamination was present throughout the southern end of the excavation (Photo 1, Figure 6-1). Brown staining suggested that surficial contamination was associated with hydrocarbon migration from the tank fill ports which were located in this vicinity.

Photo 1. Stained Surface Soils at South End  
of Diesel Tank Excavation

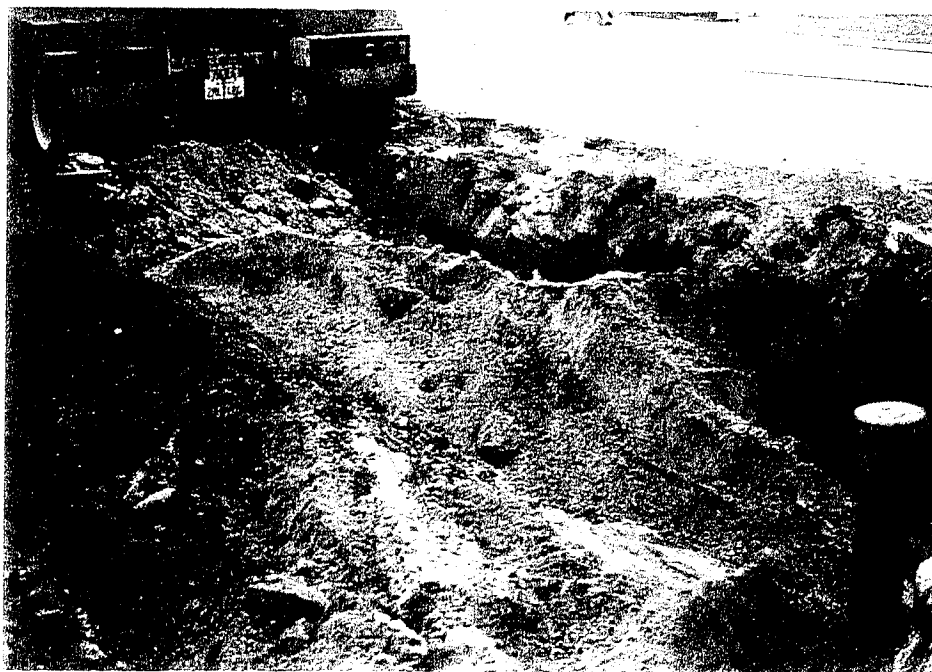
Within the diesel tank excavation, a fine- to coarse-grained sand, red-brown to gray in color, with varying percentages of gravel, pea gravel, and brick fragments was observed. This lithology apparently represents fill materials.

Photo 2. Soil Types in Diesel Excavation

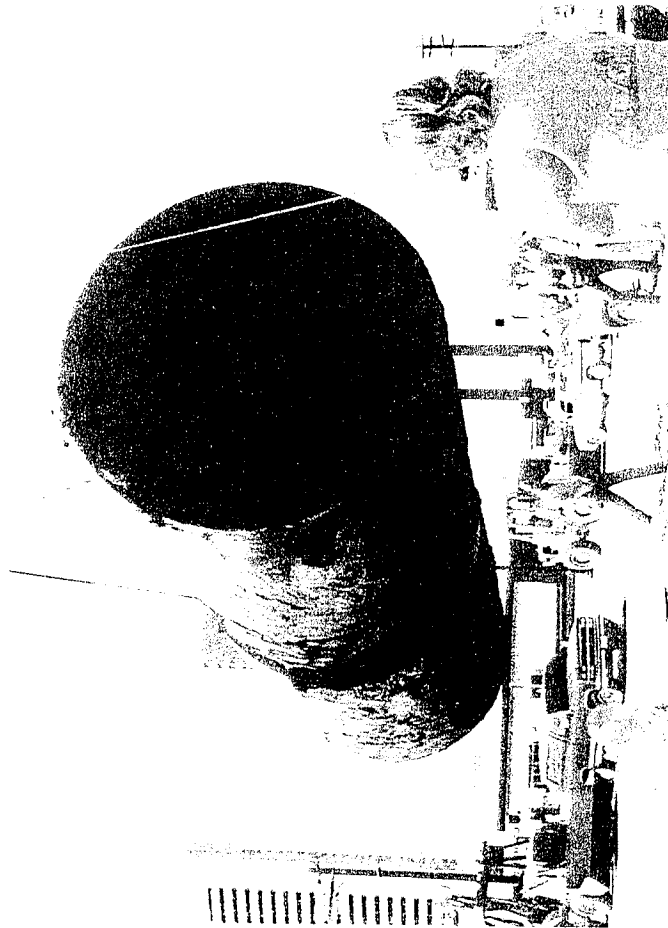
6-4

Western Diesel Tank

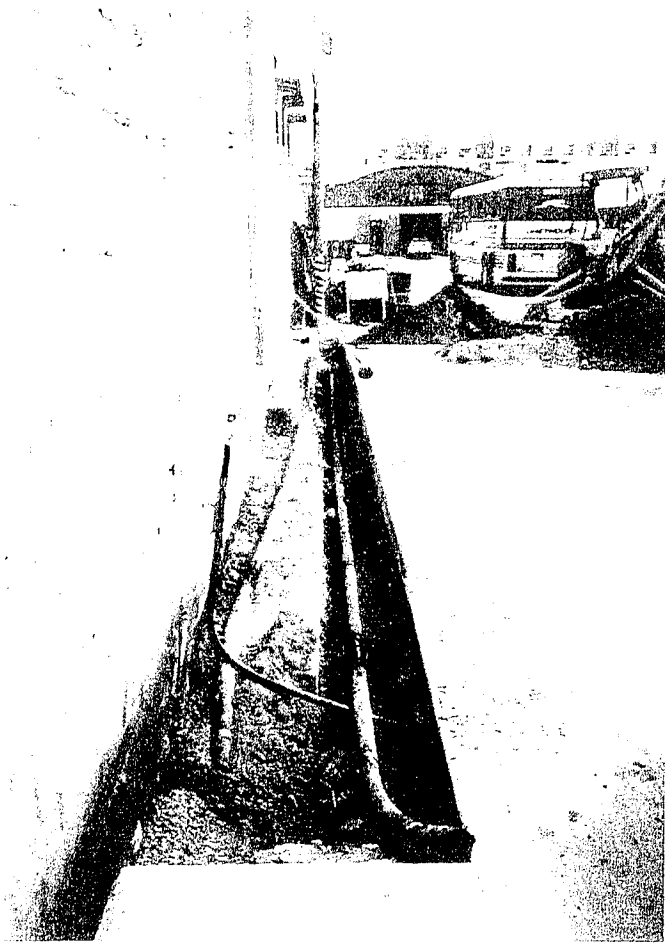
Photo 2. Looking south at former fuel lines
