# **Closure Report Greyhound Lines, Inc. Maintenance Center**

San Diego, California

Volume I - Technical Report

**February 1990**

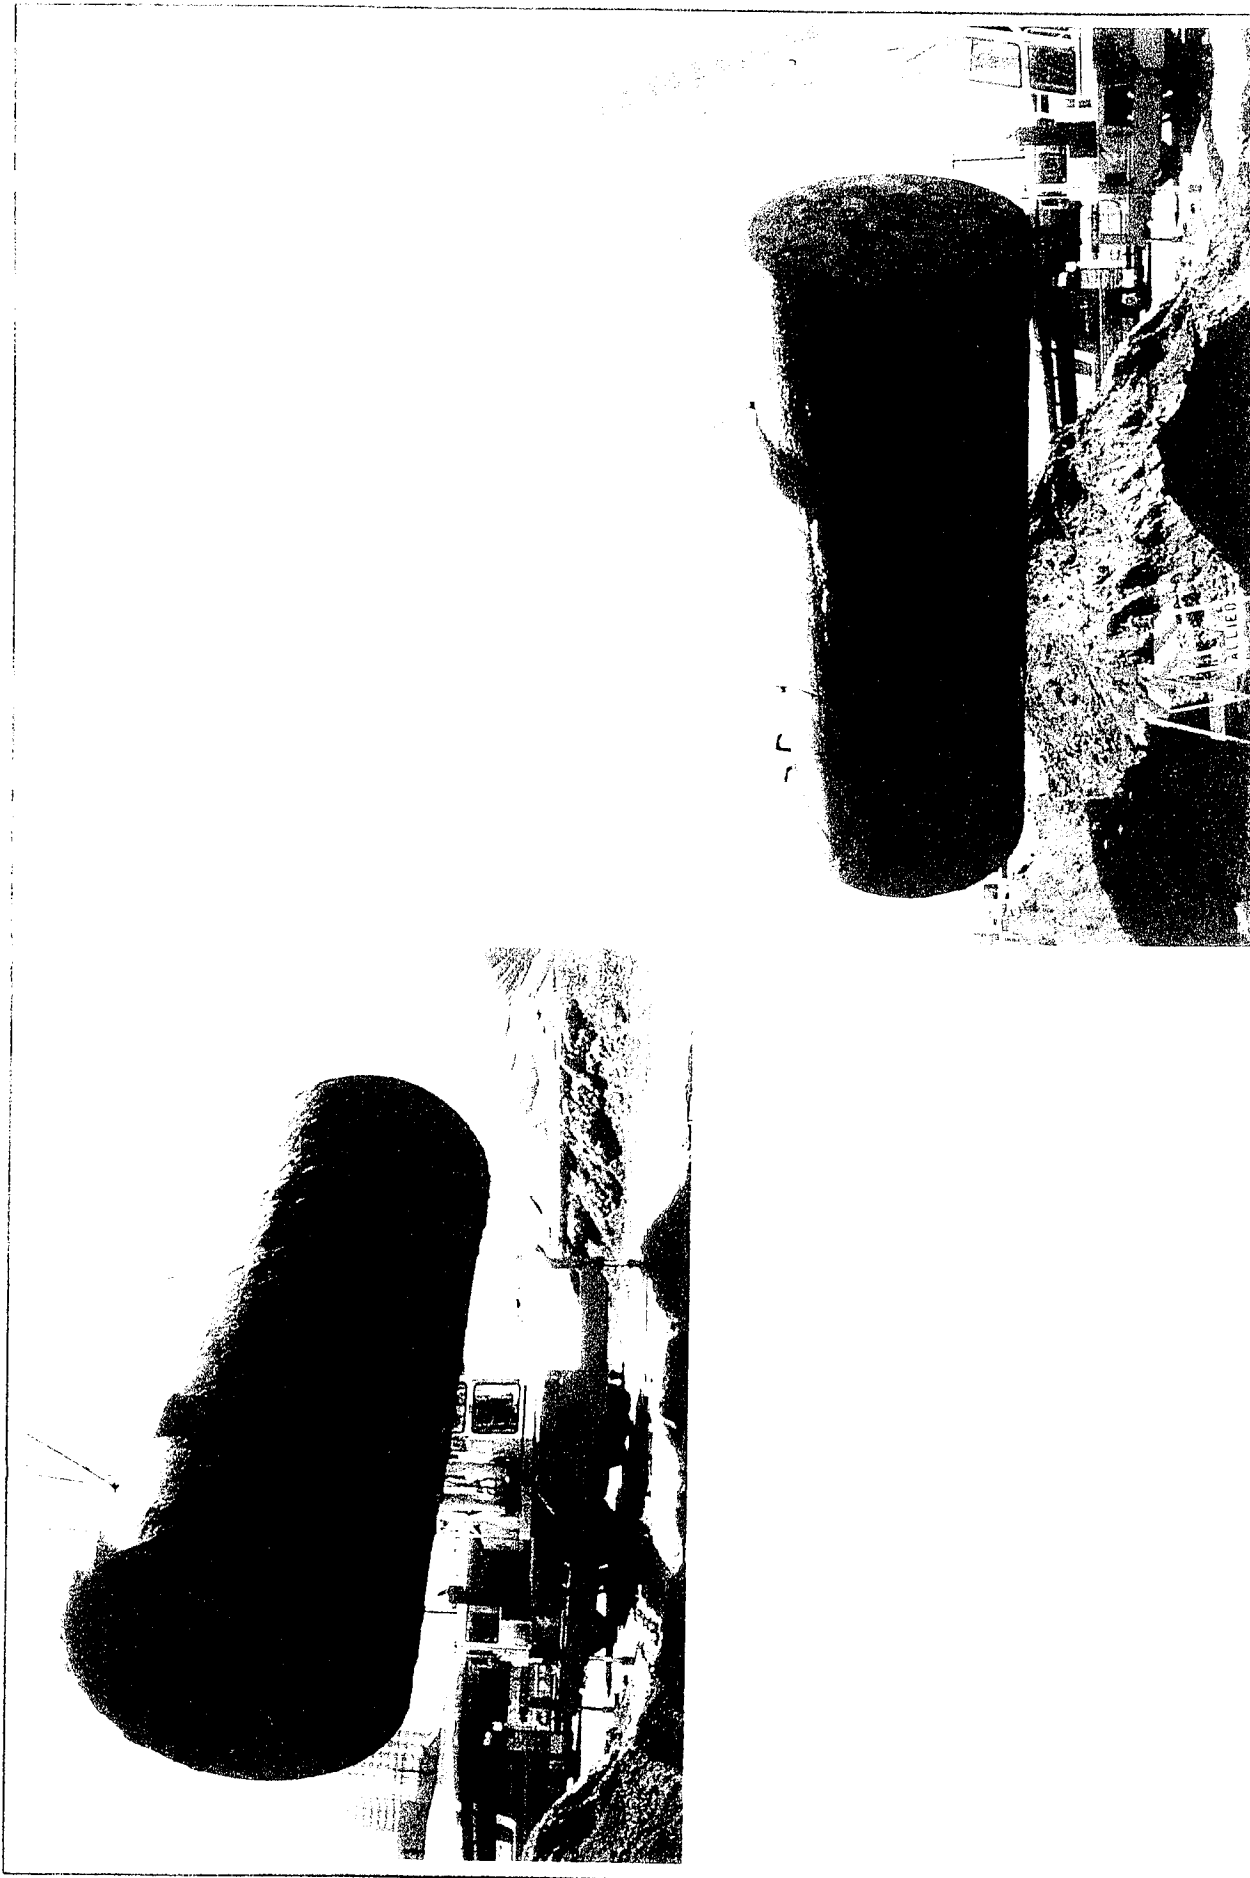
Western Diesel Tank

The diesel tanks were inspected from above and appeared to be in good condition. The soils in contact with the diesel tanks showed no visible contamination and OVA data also suggested that leakage from the tanks had not occurred. The soils were dry, to slightly damp with water moisture.

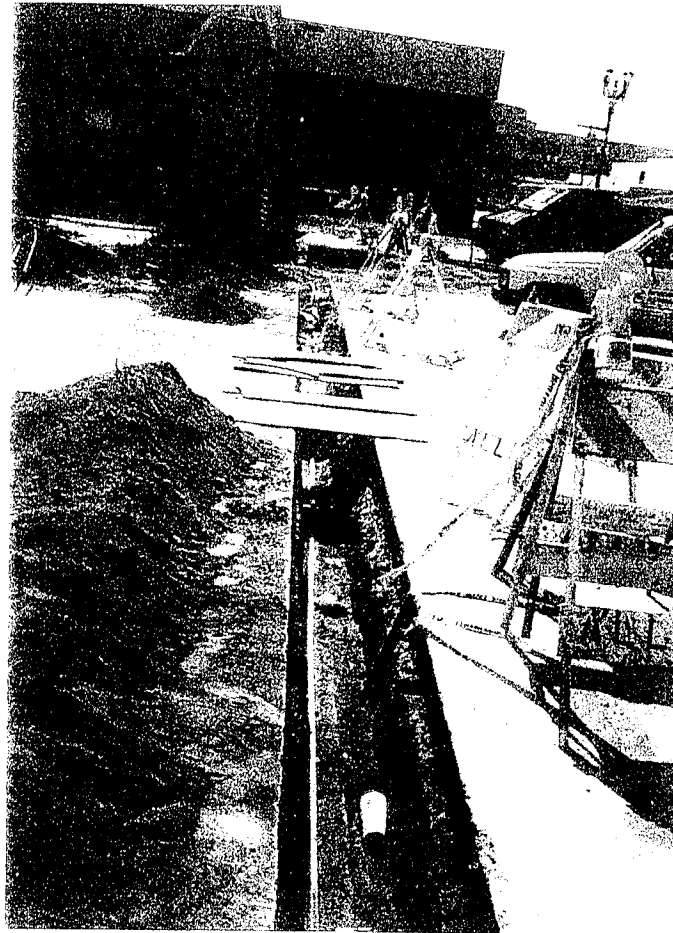
The diesel line running north/south between the lube oil and waste oil tank excavation and the diesel tank excavation appeared to be in good condition (Figure 7-3). The bonds between joints were strong with no signs of leakage or degradation. The line trench was dry with no staining or odor, except at the north segment, closest to the diesel excavation.

It is thought that this contamination is associated with the nearby diesel fill port, rather than the diesel service line. Soil samples OE51 and OE52 were acquired from this section of the service line trench.

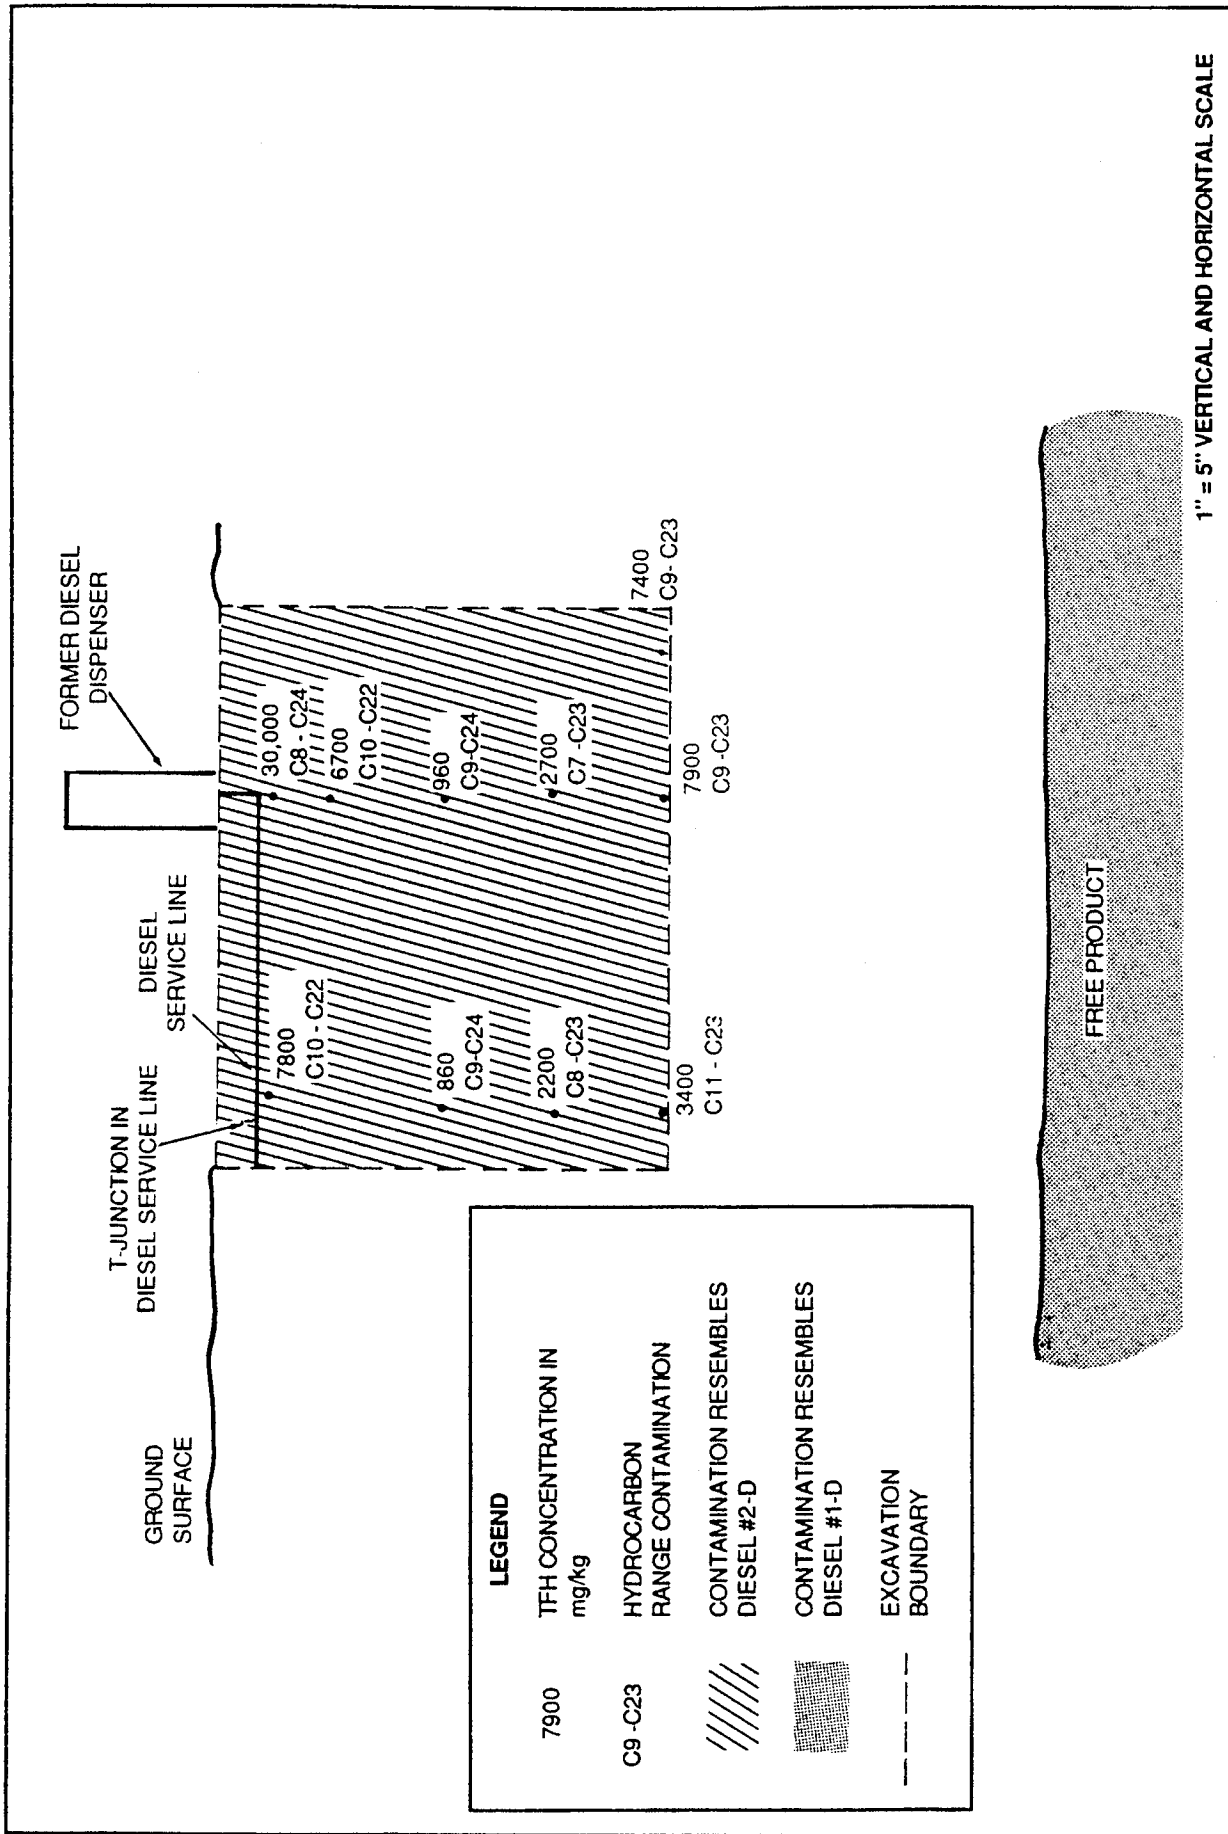
8-4

Soil contamination in the dispenser area was remediated to the north and east by soil removal. Contamination to the south, west, and vertically was not fully remediated due to the close proximity of the building foundation and underground utilities.

It is believed that diesel #2-D contamination does not extend to the water-table because the free product samples taken from MW3 and MW4 located near the dispenser area resemble diesel #1-D. There is no evidence that diesel #2-D has been introduced into the plume.

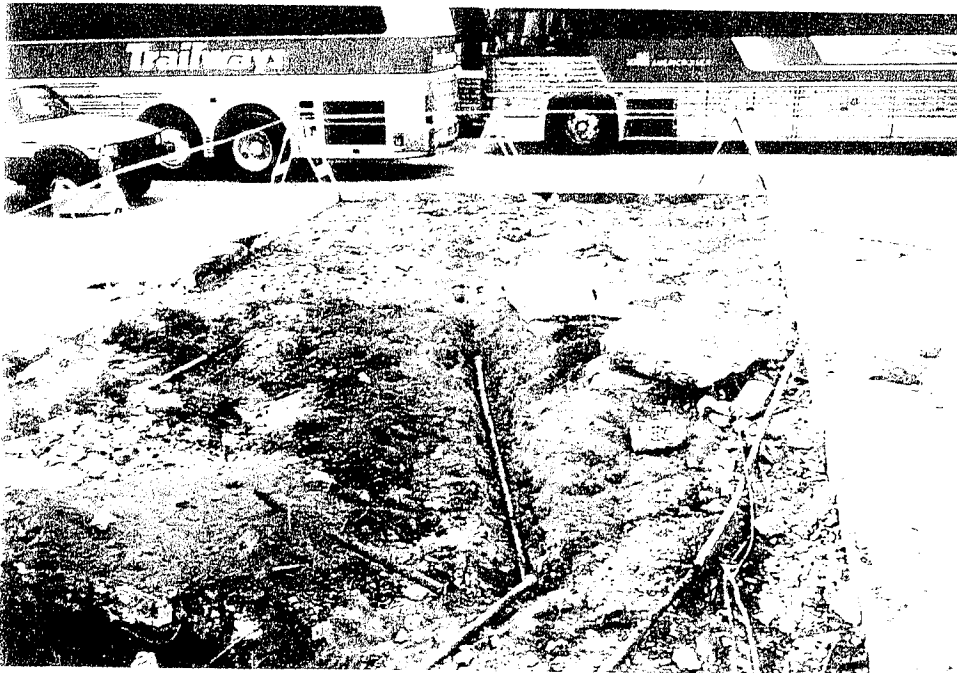
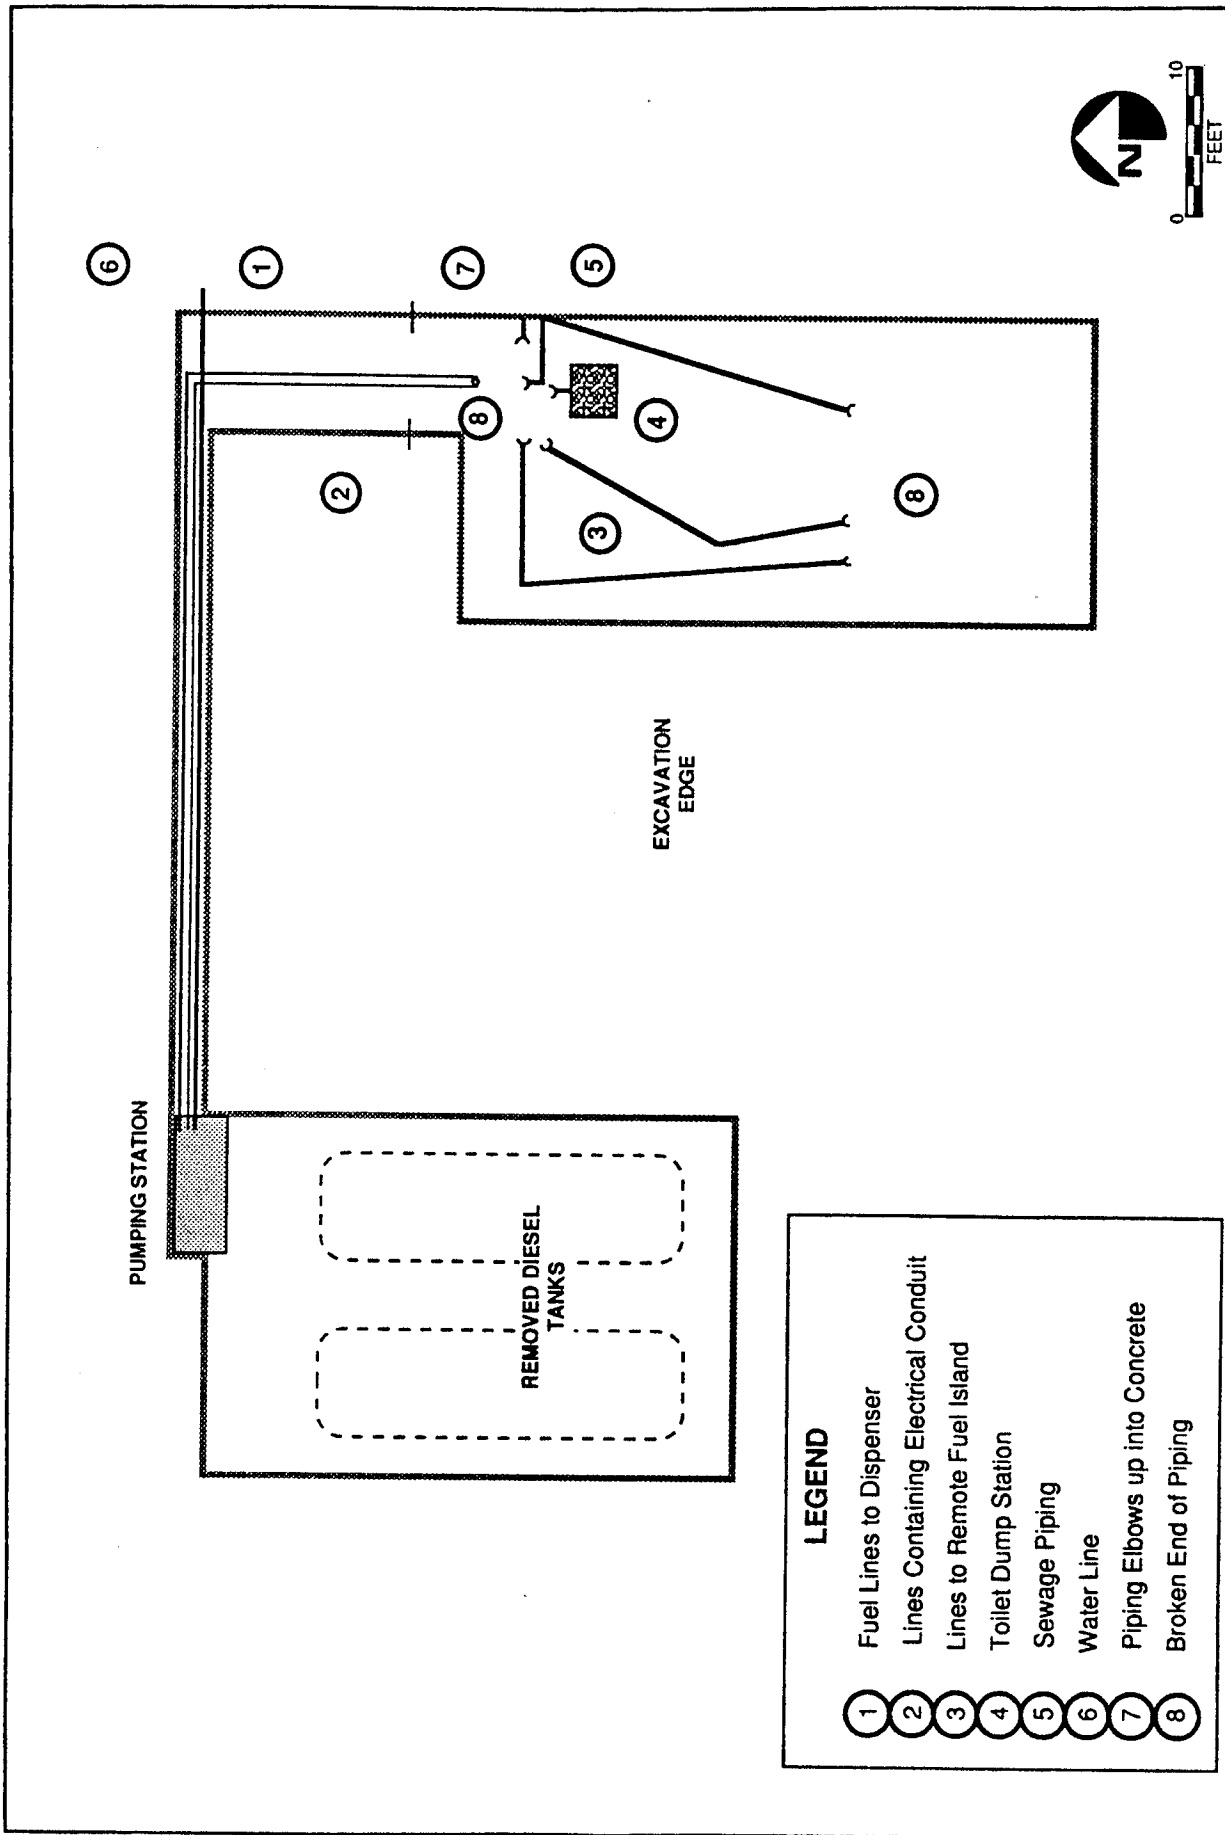
Structures Exposed During Excavation of Pre-1974 Pipelines

Photo 2. Looking south at former fuel lines

The two lines, apparently associated with the fueling operations at GLI prior to 1974, extended approximately 18 feet south of the property and then elbowed up into the concrete. Corrosion was present along these lines especially where they terminated. This location appears coincident with a location of a wall-mounted fuel dispenser associated with the former service bay structure (Section 2.3).

The earlier noted line that headed west, turned south at a swivel joint. The southwest heading line turned south at an elbow joint. These two lines and a third line heading south terminated 38.5 feet south of the northern property edge as seen in Photo 2 in Figure 9-1. These lines had not been placed in backfilled trenches, rather lay unprotected just beneath the concrete slab. The lines appeared to be tar coated, but in most areas the coating had flaked off the lines. The eastern and central line were in the best shape. The western line, however, was quite corroded and was underlain in some spots by severely stained soil. The soil emitted a degraded hydrocarbon odor. None of the lines were capped at the ends.

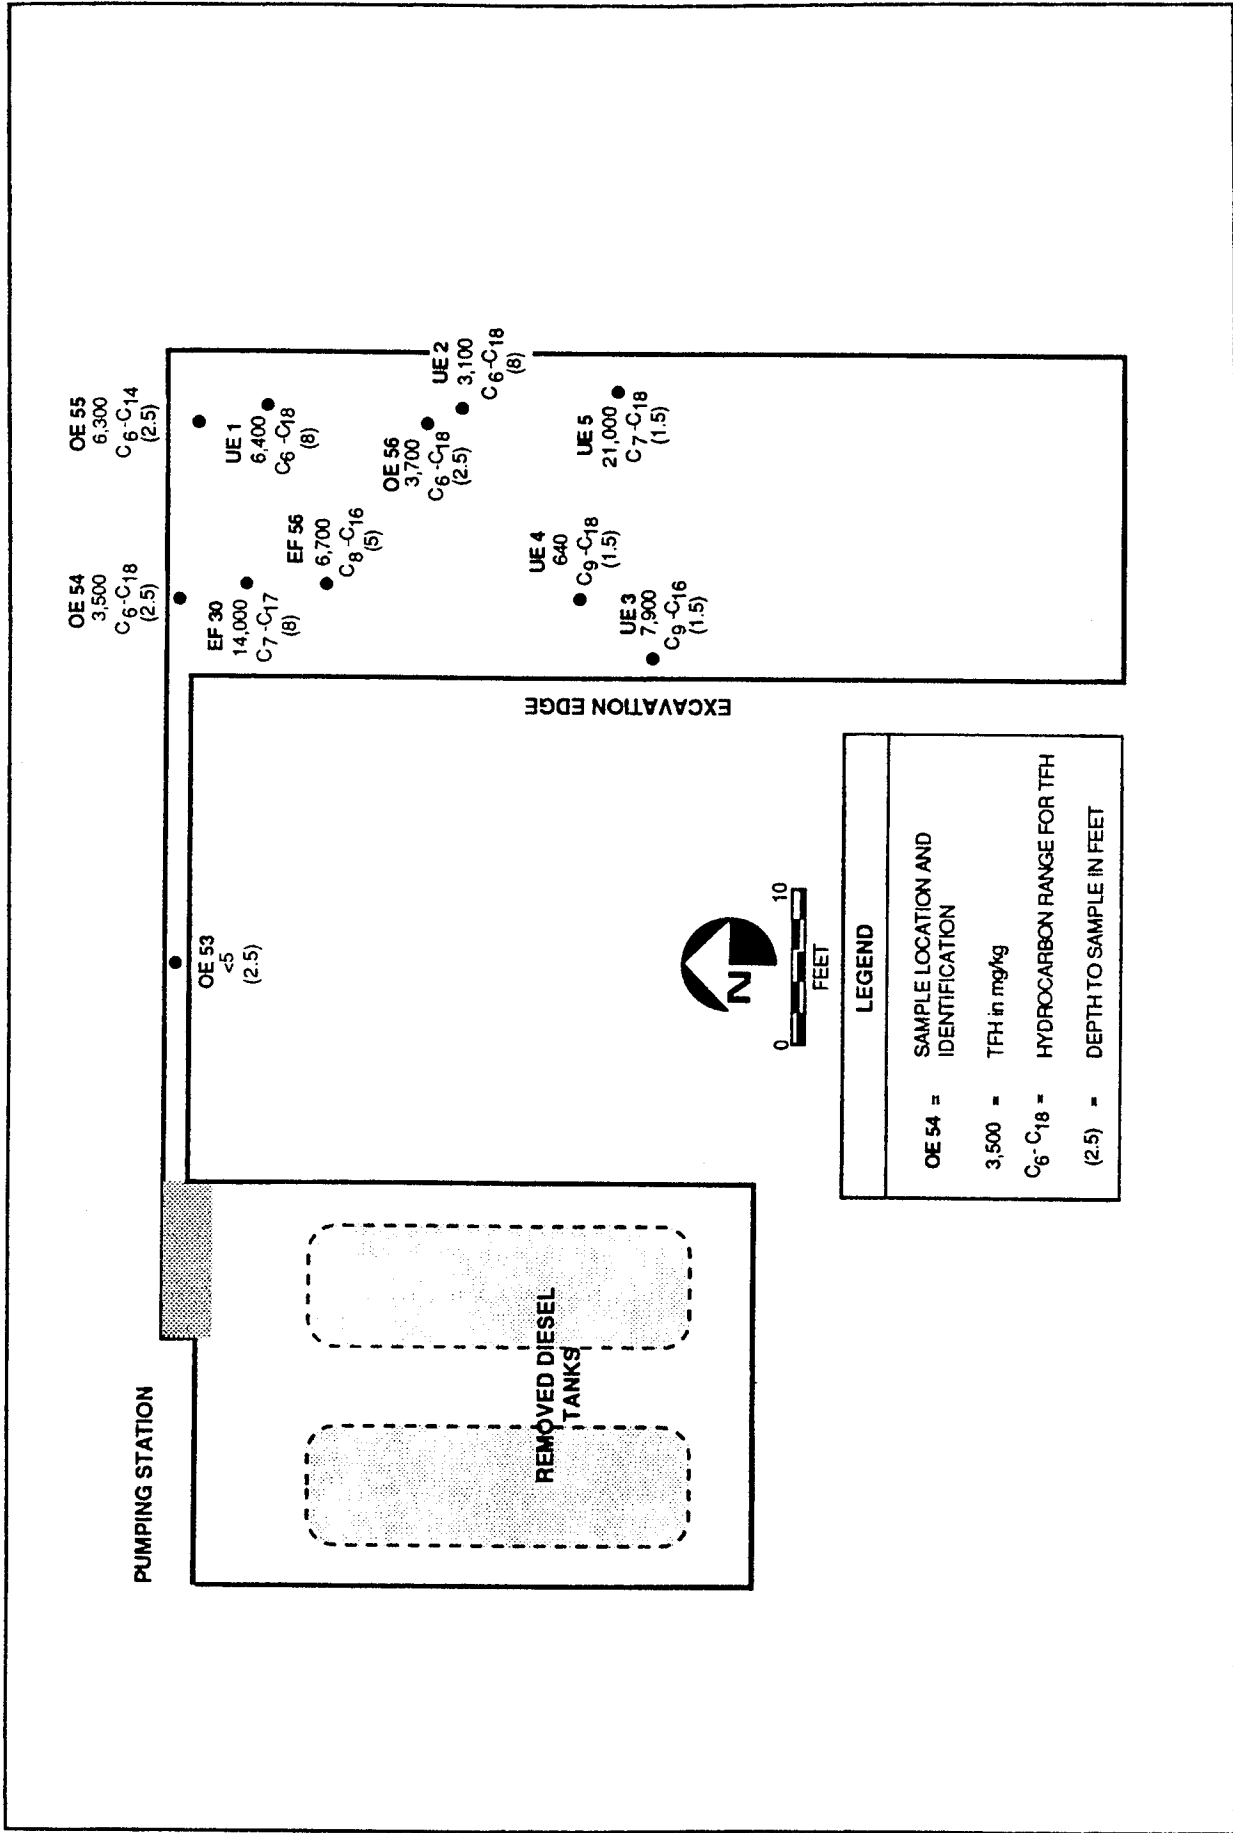
FIGURE  
**9-4**

TFH Results in Soil Samples Beneath Pre-1974 Pipeline

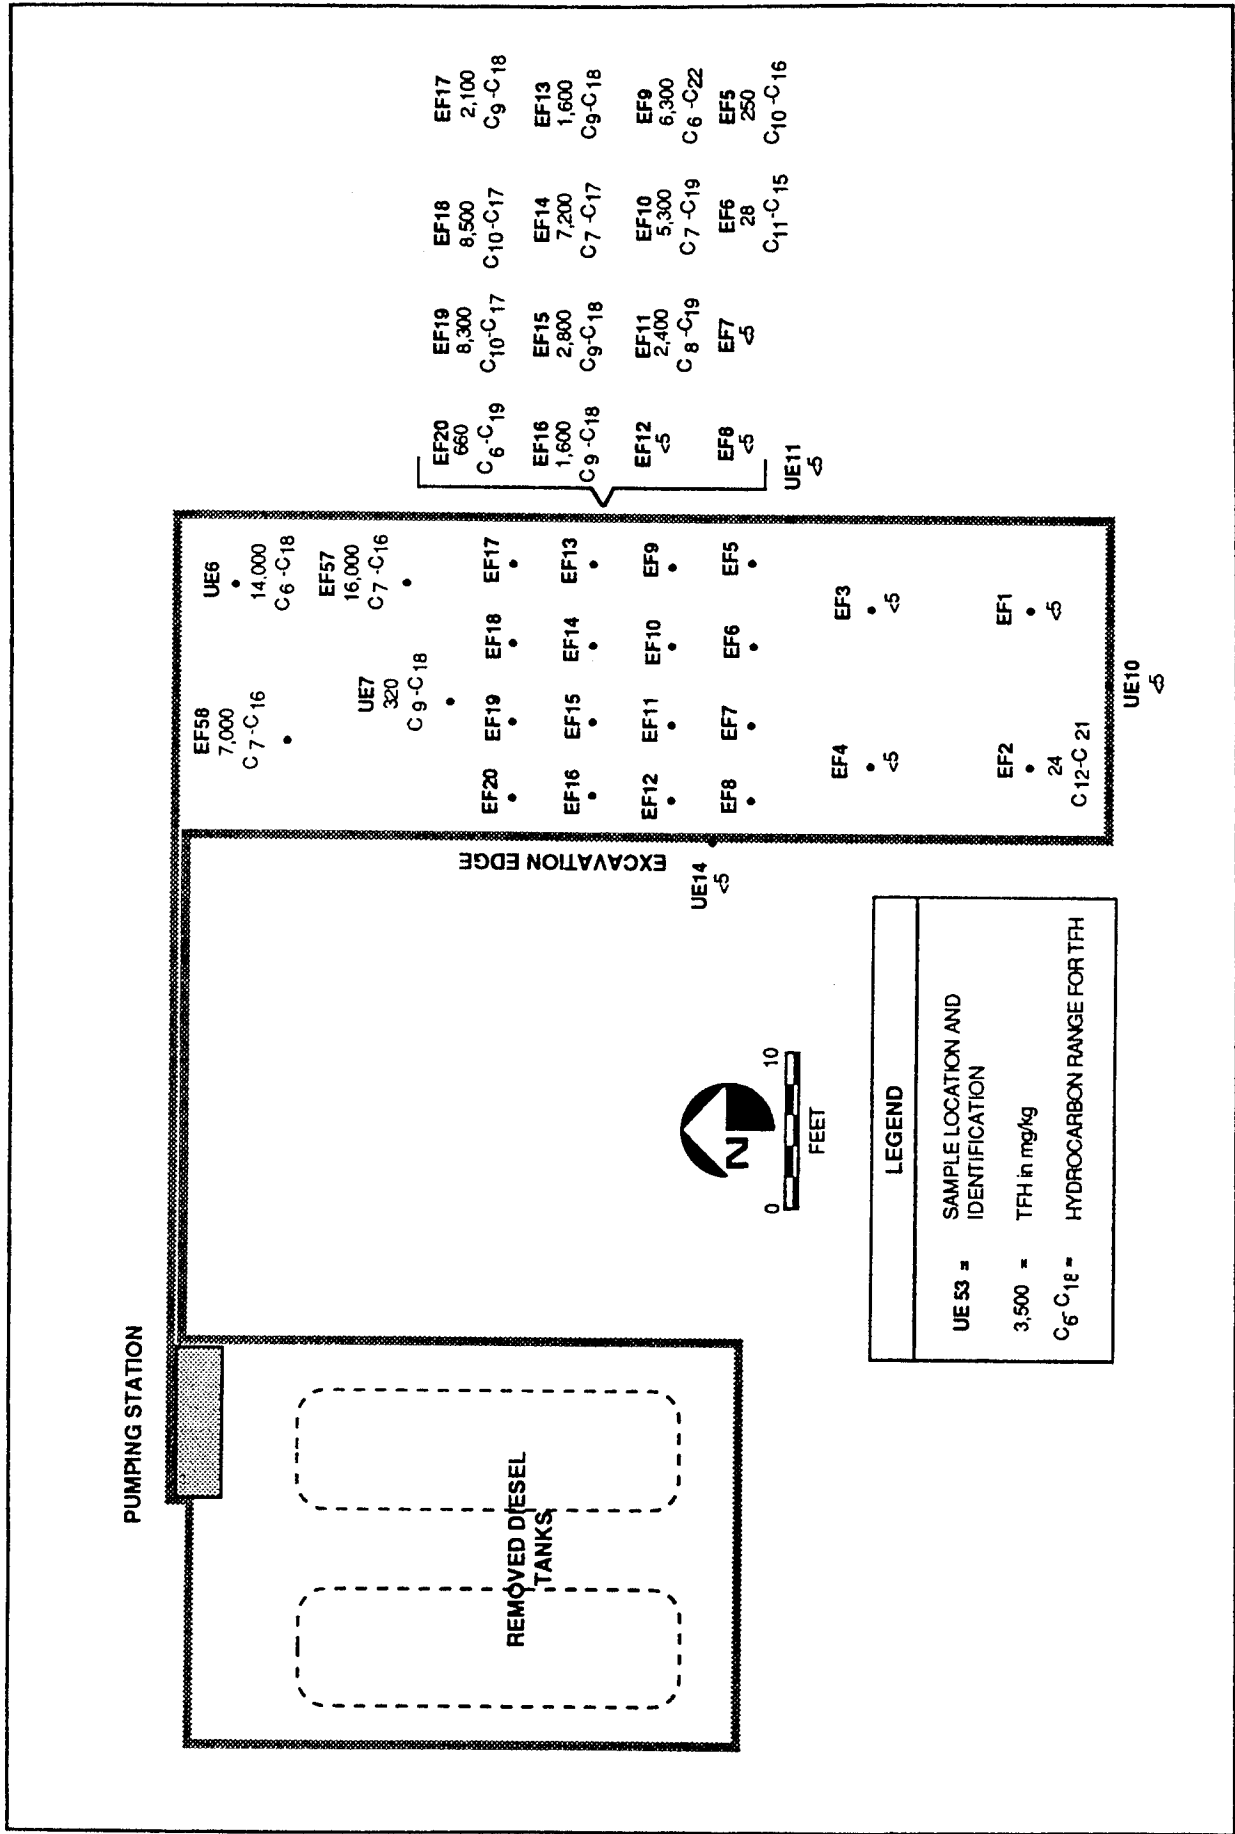
9-5

TFH Results in Soil Samples from 13 ft. Below Ground Surface

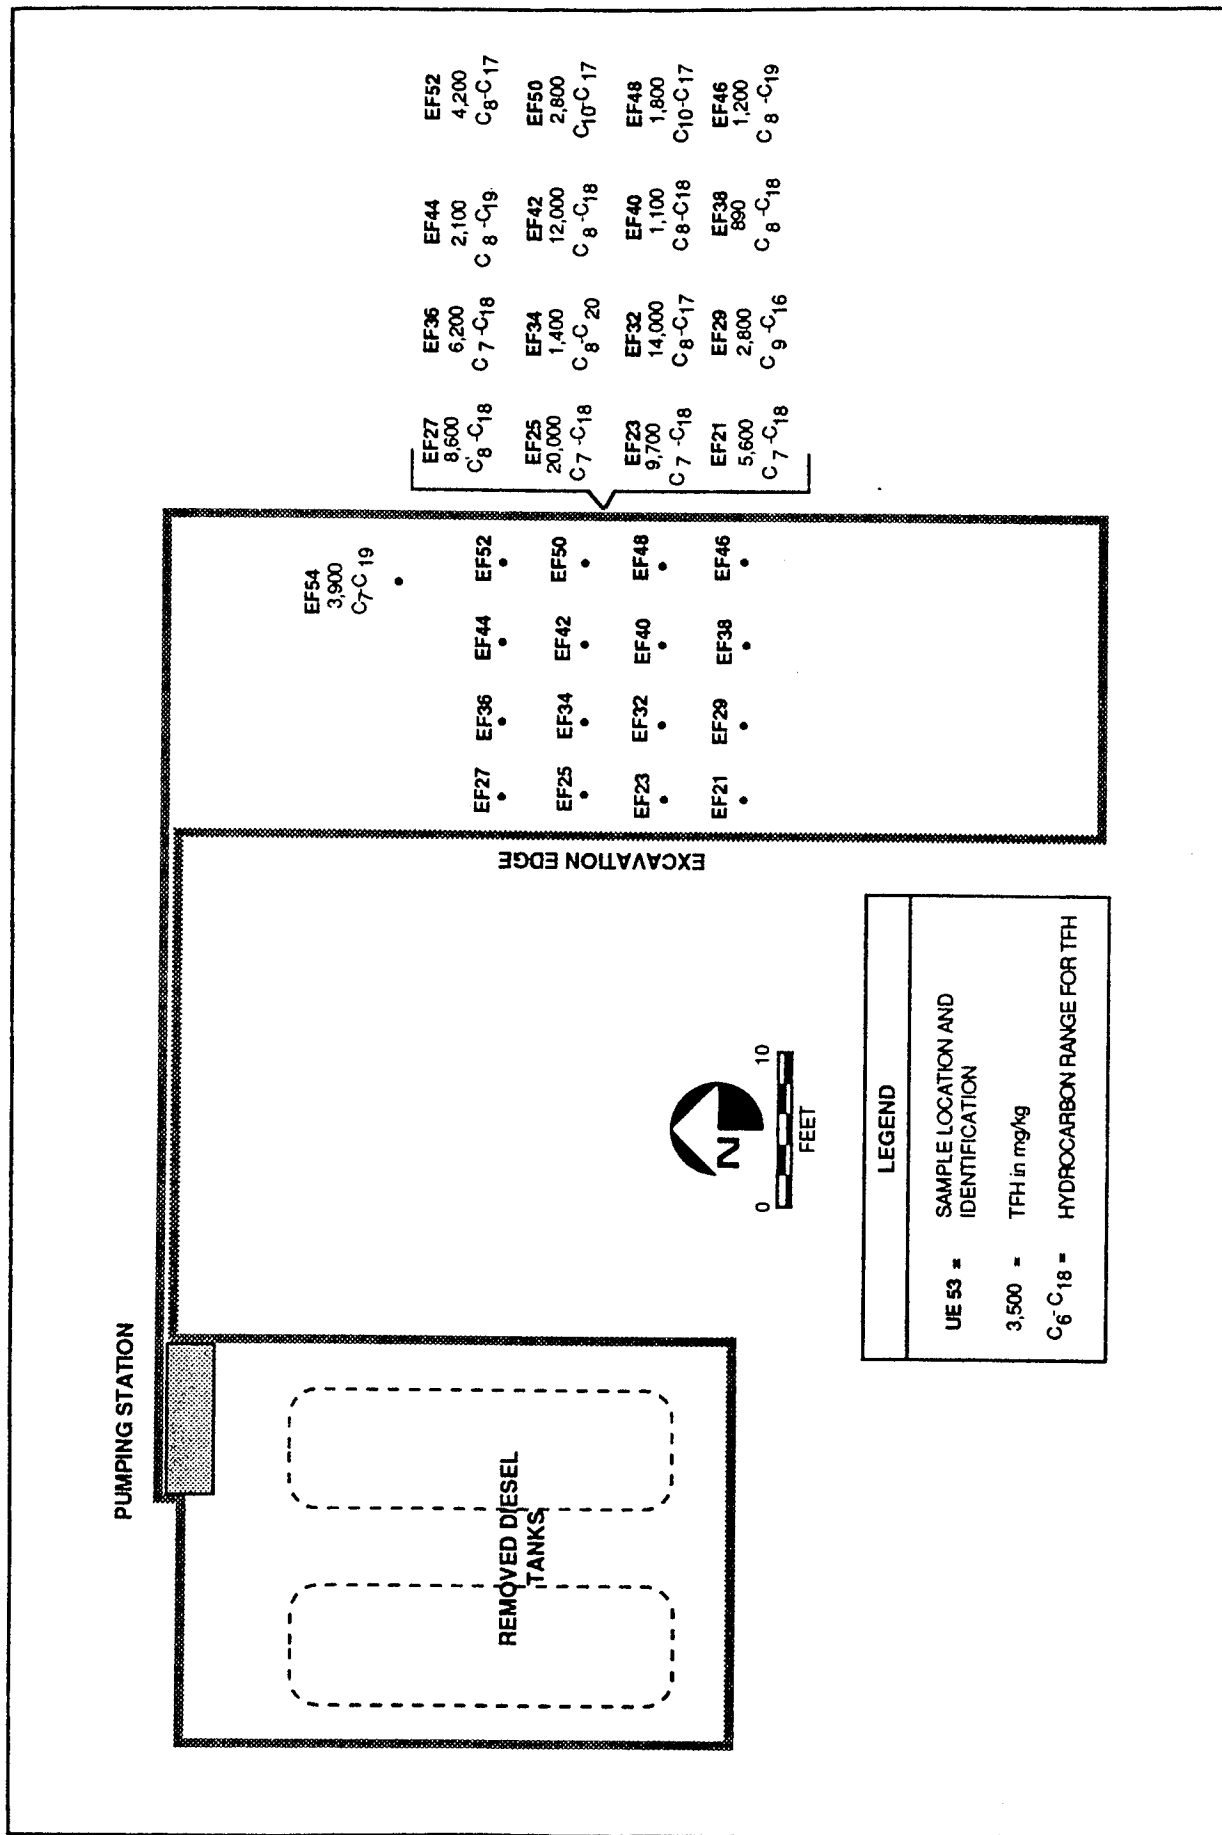
9-6

TFH Results in Soil Samples from 15'6" Below Ground Surface

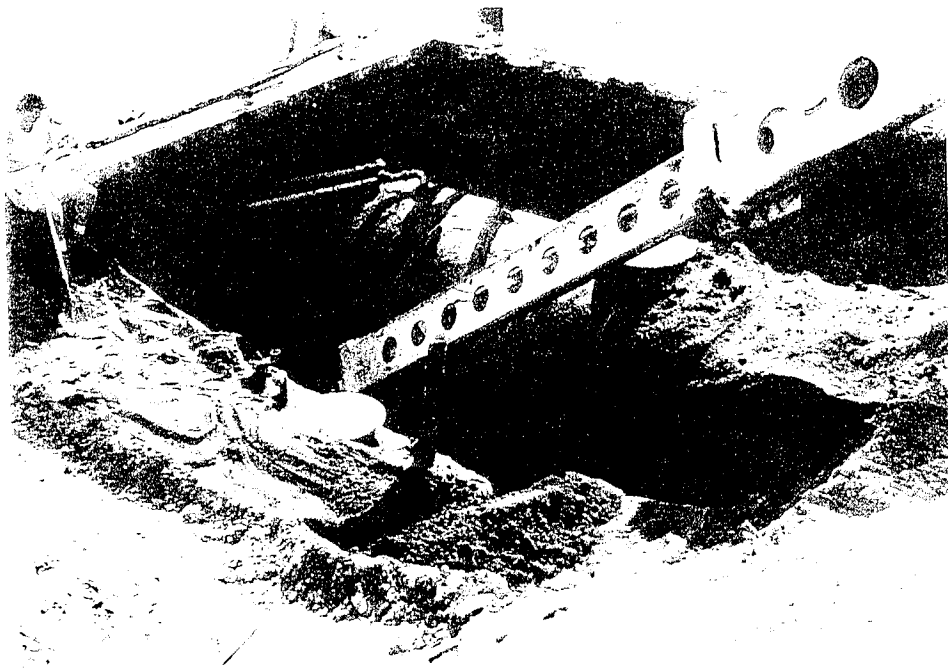
The oil tanks were inspected from above and appeared in good condition (Photo, Figure 11-1). No signs of leakage or corrosion of the underground system was noted.

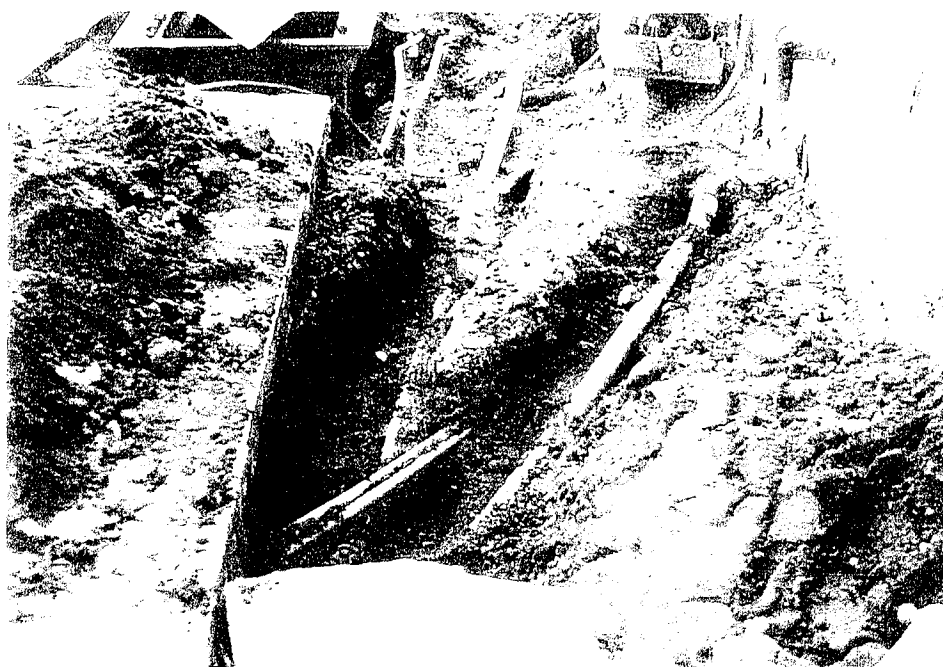
The lube oil lines were short in length, running approximately 25 feet from the building to the tank. The lines were in good condition with no cracking, splintering, or sponginess noted. There did appear to be a leak associated with a coupled area, just outside the building wall (Photo, Figure 12-1). The area was stained gray and had a fairly strong sewage odor. As noted above, the waste oil line also crossed the area of contamination and was likewise coupled in the vicinity. The soil contamination is thought to be associated with the lube oil line due to the fairly light coloration of the soil staining.
